## Apartment Building in Brogården, Alingsås SE

### PROJECT SUMMARY

IEA SHC Task 37

Advanced Housing Renovation with Solar & Conservation

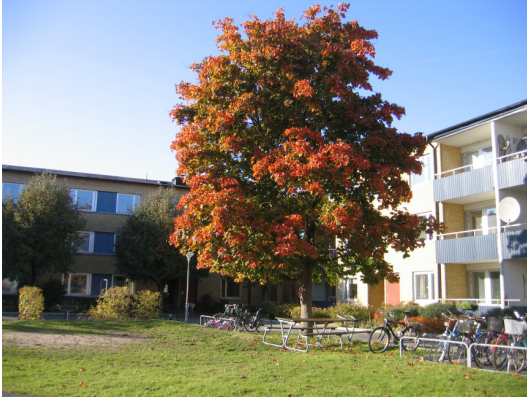
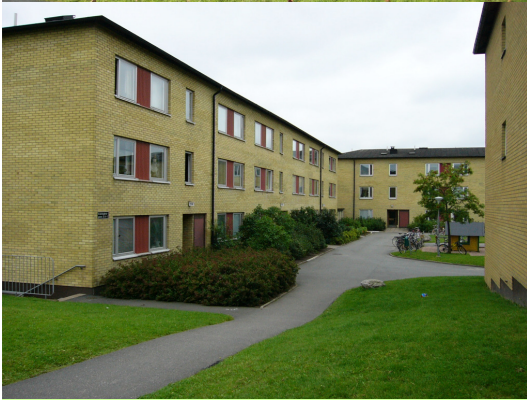
Brogården before renovation

The Brogården housing estate with 300 apartments built 1970 was in great need of renovation. The tenants complain about draughts and cold apartments and the facade exterior had mouldered away. The apartments were not suitable for elderly or disabled persons. Renovation was needed in any case and energy aspects were to be included. Initially, one building with 18 apartments were renovated and serves as a demonstration project. Renovations following this demonstration phase will profit from the experience gained. The project will be monitored after completion of the renovation.

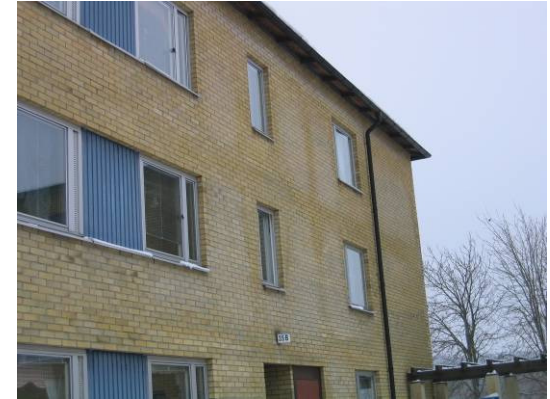
Existing facade with thermal bridges

The floor in the old balconies were made of concrete and continued with almost no thermal breaking insulation in to the apartments. This caused a large thermal bridge and discomfort for the tenants.

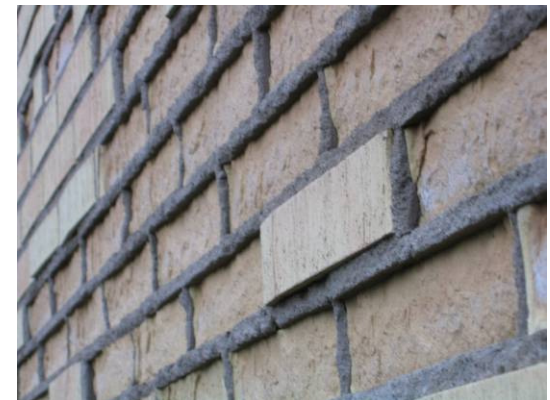
Worn out masonry facade

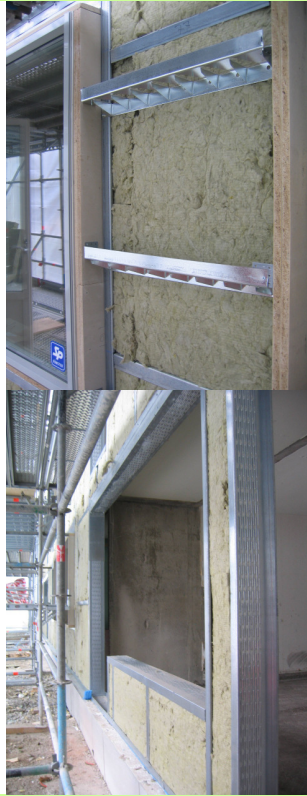
Outer wall with its layers of insulation

**Wall construction** *U-value: 0.11 W/(m<sup>2</sup>·K)*

(interior to exterior)

Interior plaster	13 mm
Steel beams + mineral wool	70 mm
Plastic foil	
Steel beams + mineral wool	120 mm
Steel beams + mineral wool	195 mm
Steel beams + mineral wool	95 mm
Shield of brick	22 mm
<b>Total</b>	<b>515 mm</b>

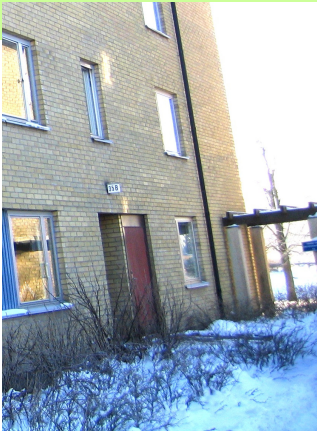
Entrance before renovation

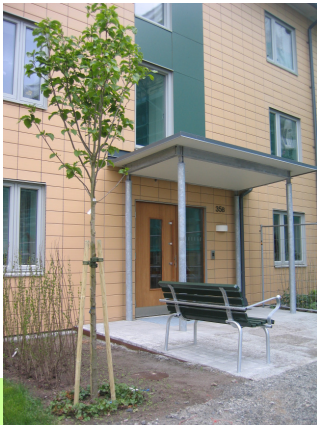
Entrance after renovation

The entrances were rebuilt to be easier to access and more distinct. A storage room for wheelchairs, walking frames and prams was built on the ground floor.

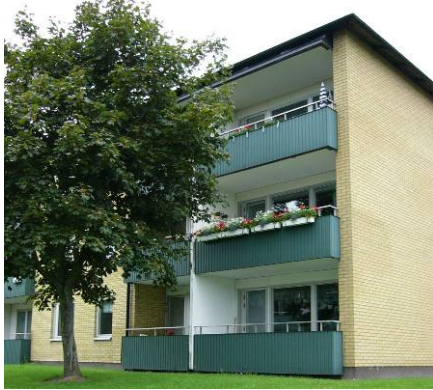
Before renovation

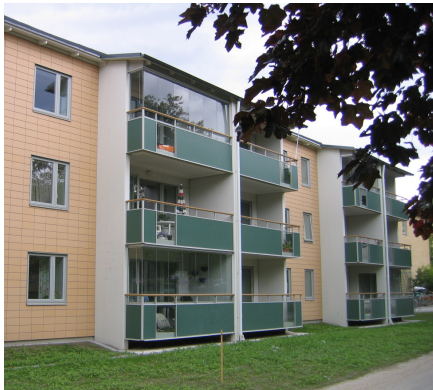
After renovation
